Chuangxin Online Test Center Laboratory

Report No:	SZ09012021001
Date:	2021/09/01
Page:	1/11

Project Inspection Report

Company : NA
Address : N/A
Sample Name : EPM2210F256C5N
Manufacture : ALTERA
Date Code : 2125
Package Type : BGA-256
Sample Number : 1 PCS
Check Number : 1 PCS
Date of Received : 08/30/2021
Date of Tested : 09:00/08/30/2021 ~ 14:20/30/26/2021

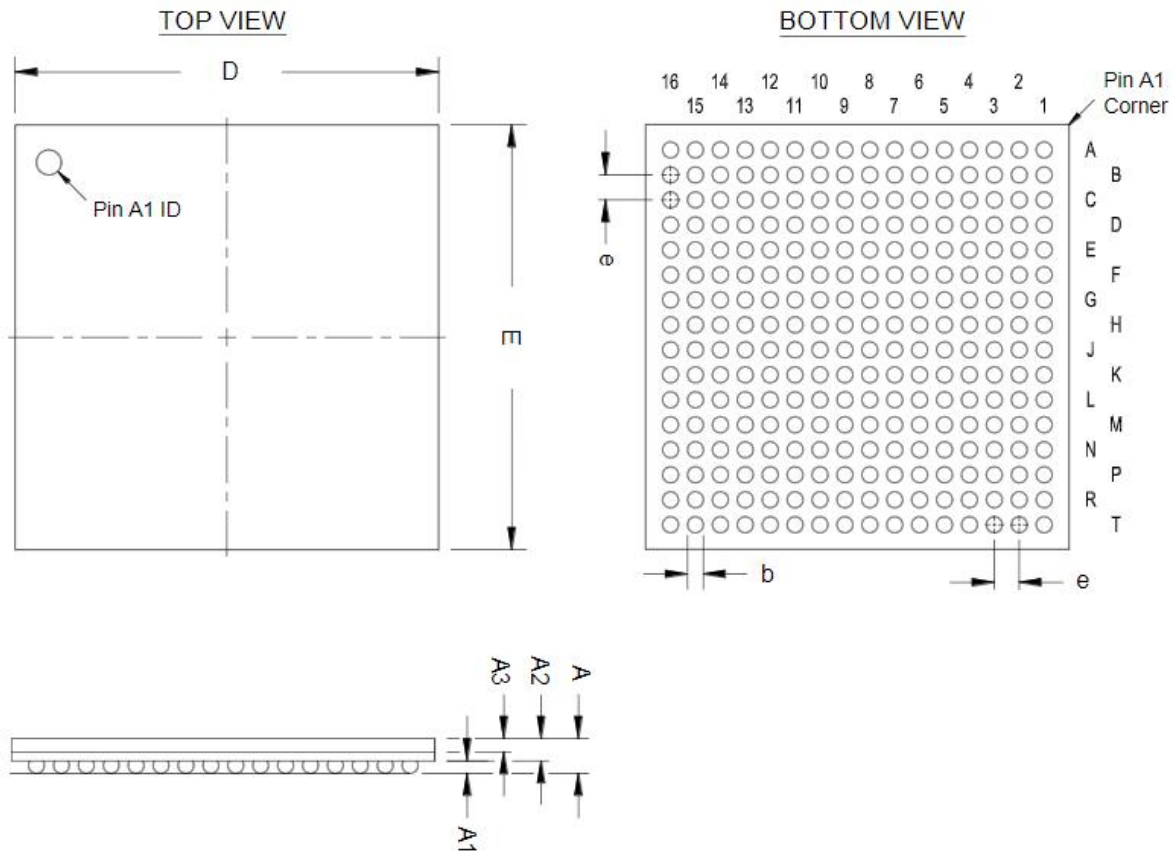
Package Outline Dimension Table			
Symbol	Millimeters		
	Min.	Nom.	Max.
A	1.60	1.75	1.90
A1	0.40	0.50	0.60
A2	1.00	1.25	1.50
A3	0.65	0.70	0.75
D	17.00 BSC		
E	17.00 BSC		
b	0.50	0.60	0.70
e	1.00 BSC

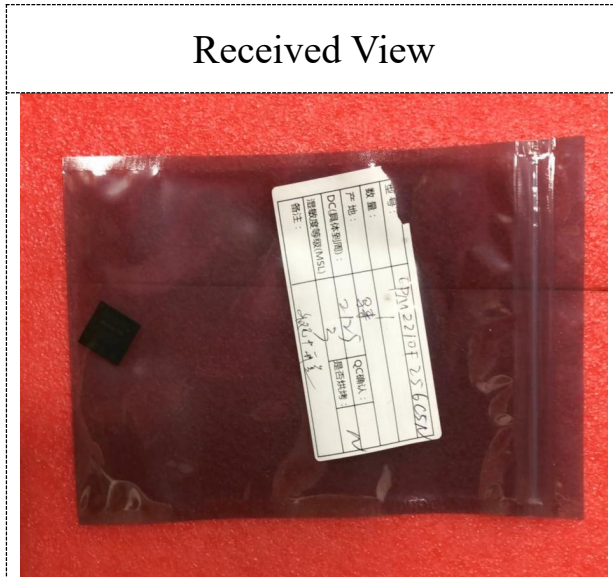
Received View

Gross Weight	4g	Parts Total	1 PCS
Number Of Boxes	N/A	Full Label	Non Present
Package type	Bulk	Moisture protection	Non Present
MSL	N/A	ESD protection	Acceptable

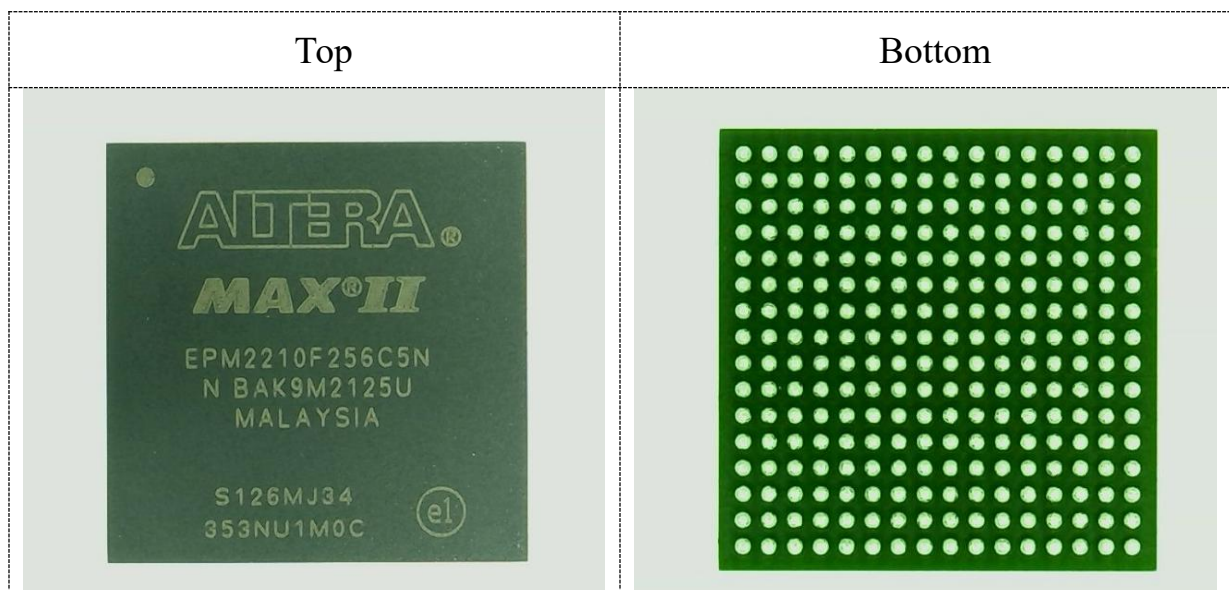
External Visual Inspection on 1 PCS sample marked with D/C 2125. No secondary coating, sanding marks, crack or chips were observed on all inspected. BGA were in acceptable condition. Devices package and dimension matched to manufacturer's specification. All devices passed the external visual inspection.

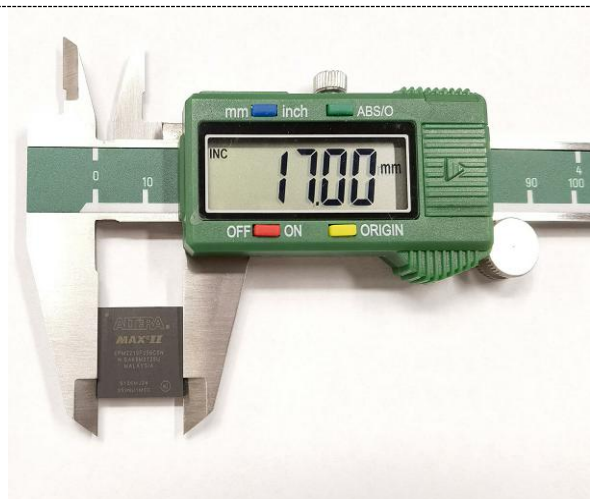
D = 17.00 MM

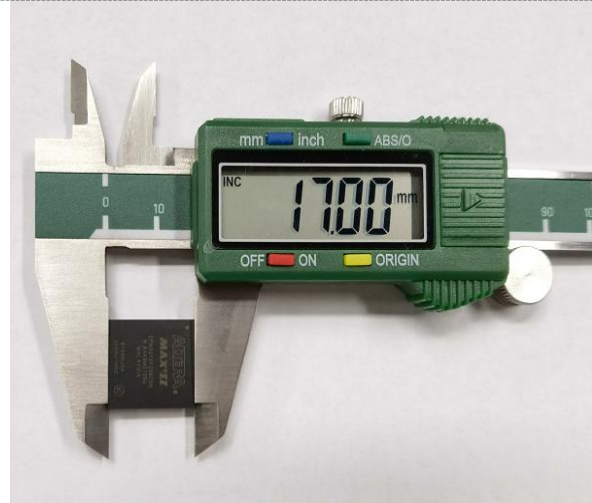
E = 17.00 MM

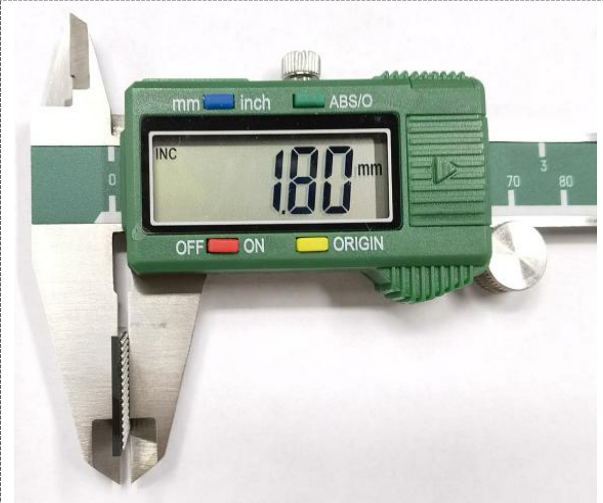
A = 1.80 MM

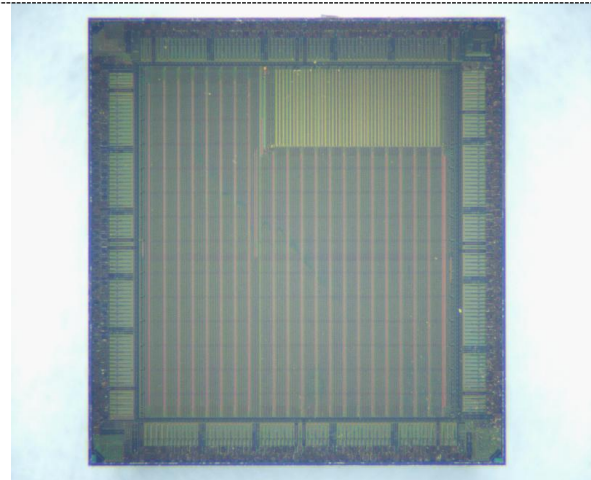
Die Topography

Internal Visual Inspection on 1PCS sample marked with D/C 2125. Manufacturer ALTERA marking were found with 2004 copyright year. Die marking Z1384 were found on the die surface. Device confirmed to be a ALTERA device.
