Report No:	SZ09142021004
Date:	2021/09/14
Page:	1/26

Project Inspection Report

Company : NA
Address : NA
Sample Name : TPS62160DSGR
Manufacture : TI
Date Code : 2105
Package Type : WSON8
Sample Number : 2000 PCS
Check Number : 3 PCS
Date of Received : 09/01/2021
Date of Tested : 14:00/09/02/2021 ~ 18:00/09/06/2021

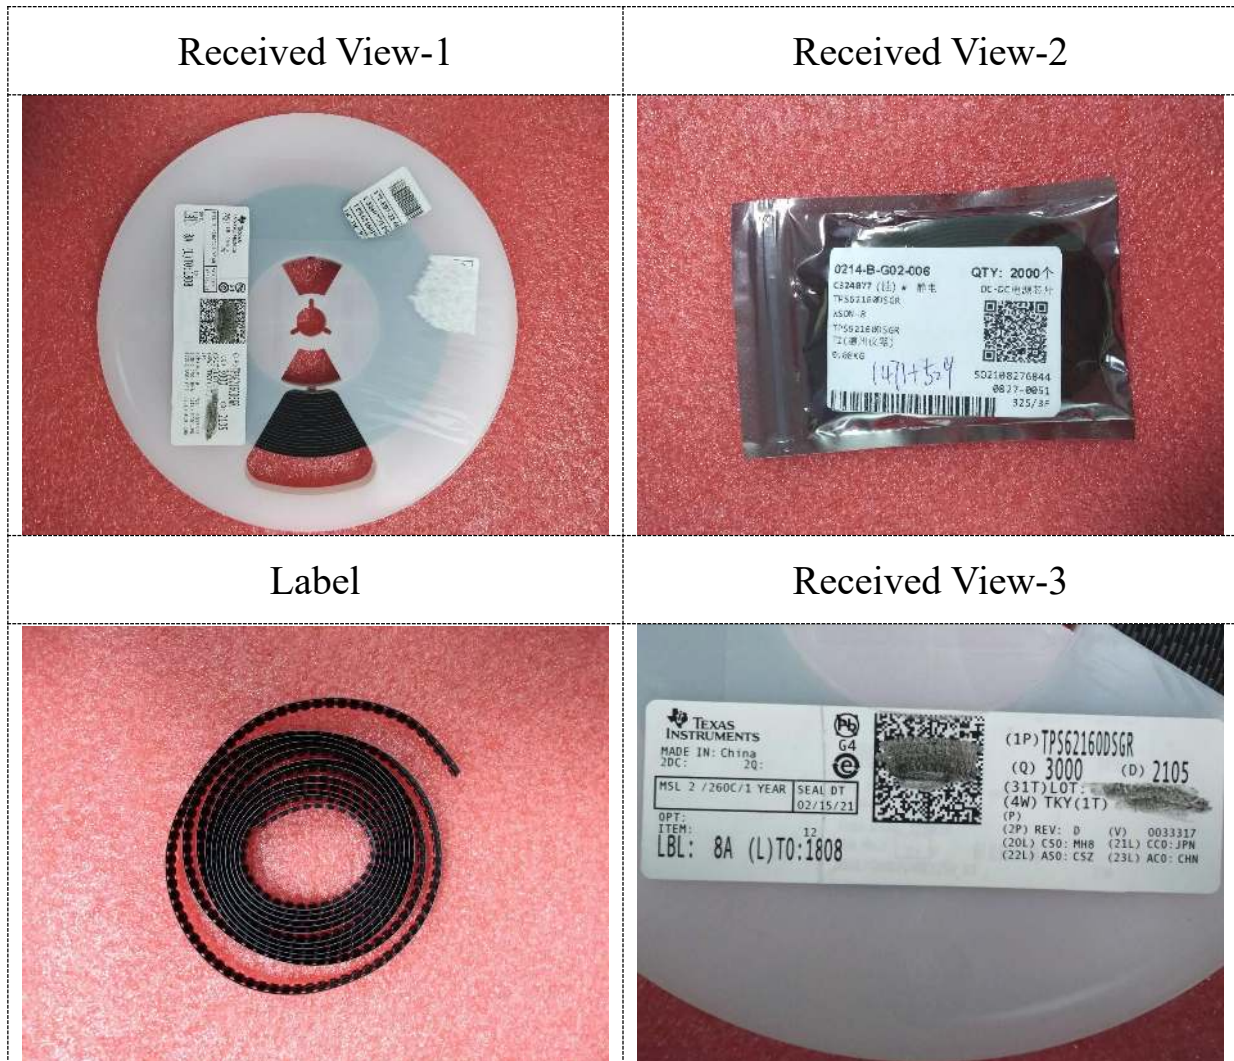
3. Receiving Inspection:

Gross Weight	87 g	Parts Total	2000 PCS
Number Of Boxes	1	Full Label	Exist
Package type	Reel	Moisture protection	Non Present
MSL	1	ESD protection	Non Present

Note: All devices contain 2000PCS samples.
 The first reel were tested 2pcs devices each: (#1-#2).
 The second reel were tested 1pcs devices : (#3).

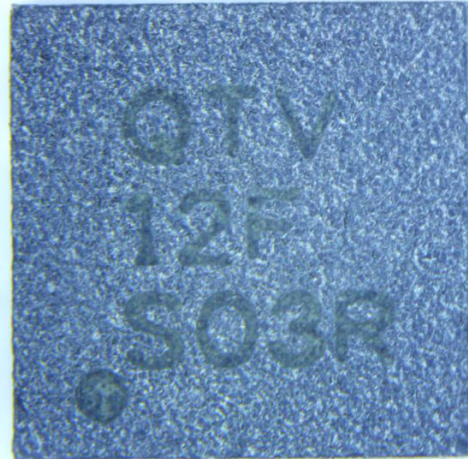
#1-Laser Marking

External Visual Inspection on 3 PCS(#1-#3) samples marked with D/C2105. No secondary coating, sanding marks, crack or chips were observed on all inspected. Leads were in acceptable condition. Devices package and dimension matched to manufacturer's specification. All devices passed the external visual inspection. Device passed top permanency tested.

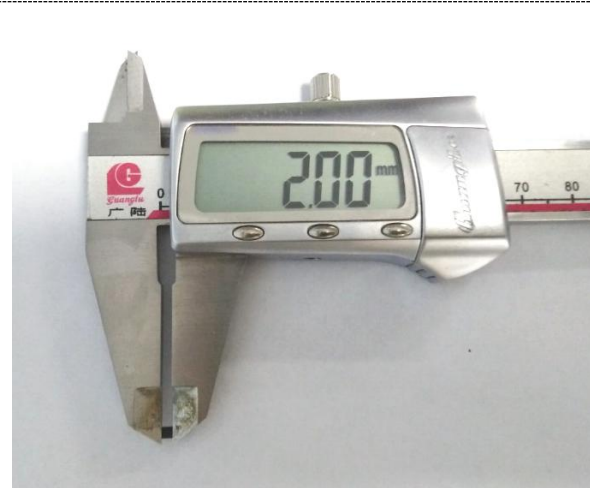
A: 1.90-2.10 MM

#1-A = 2.00 MM

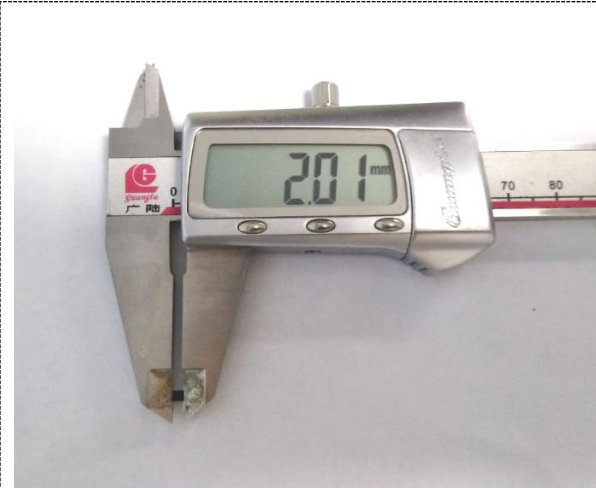
B: 1.90-2.10 MM

#1-B = 2.01 MM

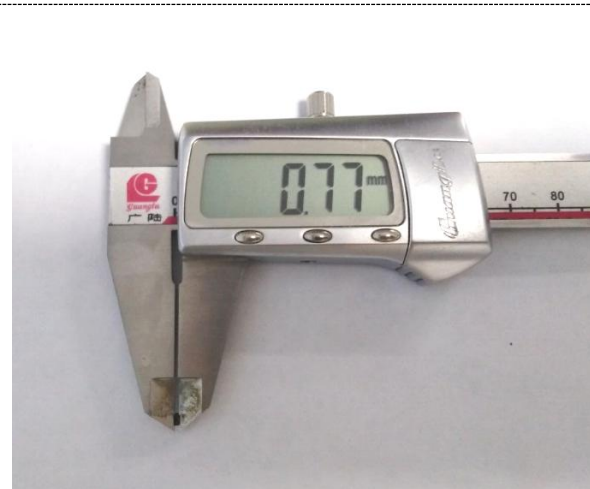
C: 0.70-0.80 MM

#1-C = 0.77 MM

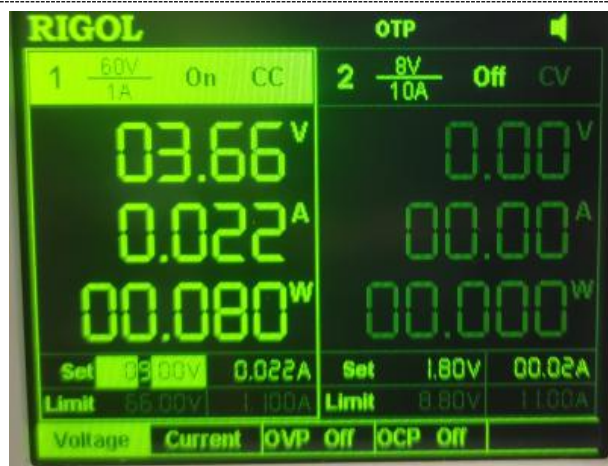
- Input voltage VIN: $3V \cong VIN \cong 17V$;
- Output voltage VOUT: $VOUT=2.5V$;
- Internal reference voltage VREF : $VREF = 0.8V$ TYP;
- Enable input VEN : $VEN = 0.9V$ MIN;

VIN = 3.66V

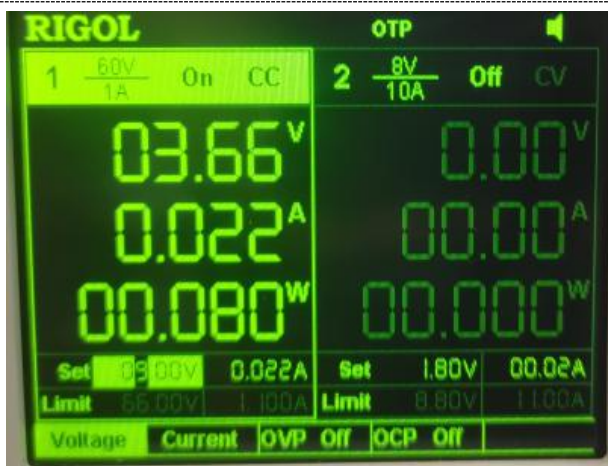
VEN = 3.66V

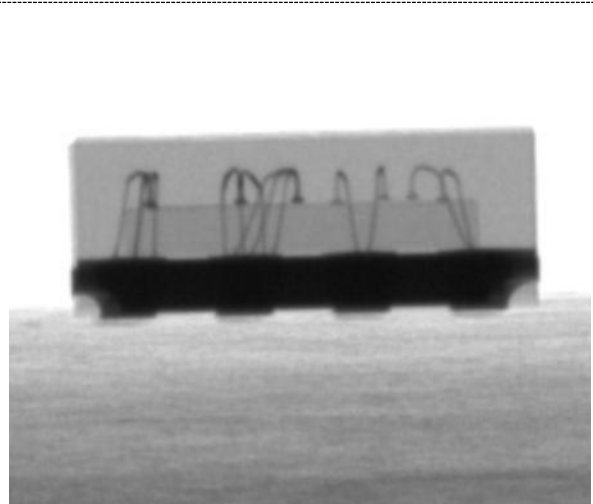
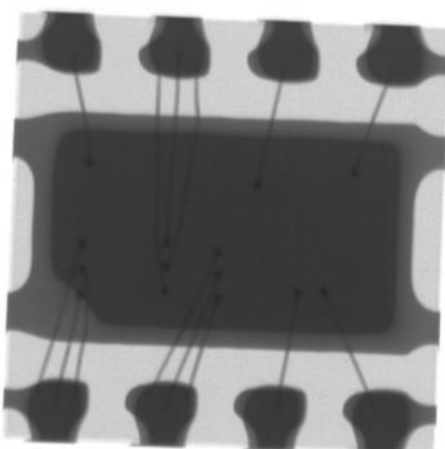
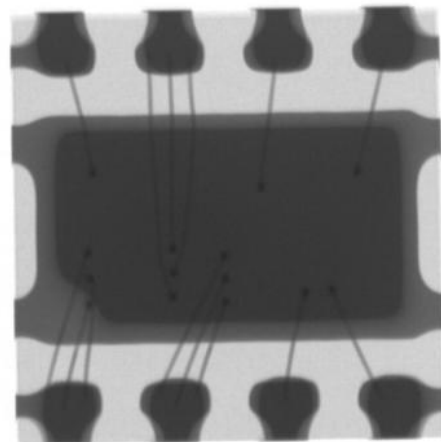
#1-Top View-All

X-ray Inspection on 3 PCS (#1-#3) samples marked with D/C2105 . No structure or bonding wire abnormal was found.

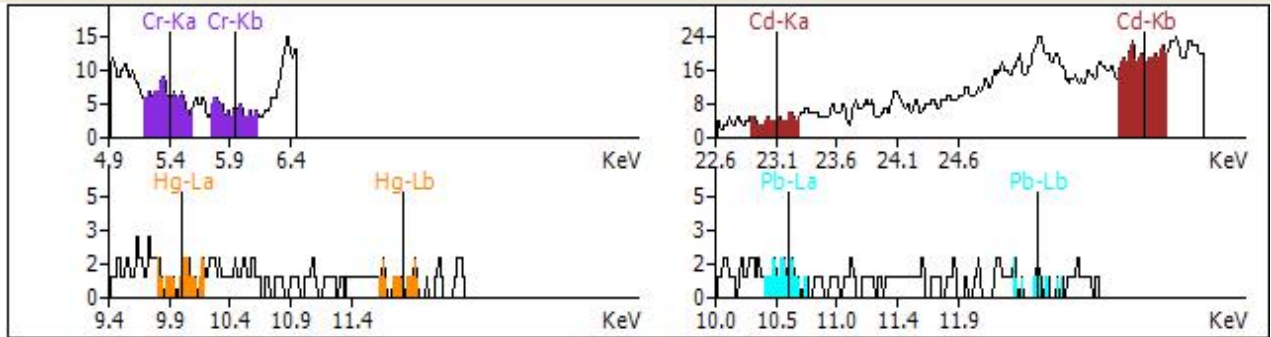
Spectrogram-1

Element	Intensity	Content (ppm)	Equipment	Error (ppm)	Limits (ppm)	Result
Cr(ppm)	0.00017	185.05	ICP-OES	10.70	1000	Pass
Cd(ppm)	0	ND	ICP-OES	0.00	100	Pass
Hg(ppm)	0.00006	ND	ICP-OES	0.00	1000	Pass
Pb(ppm)	0.00001	ND	ICP-OES	0.16	1000	Pass

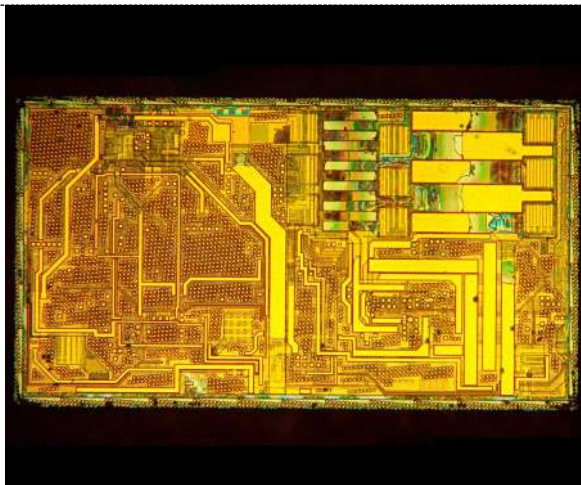
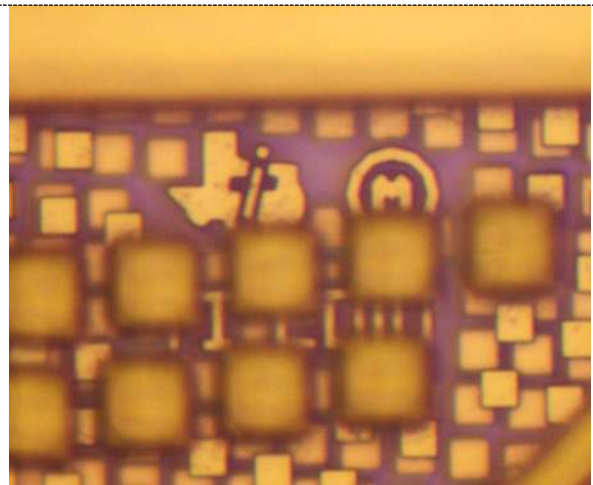
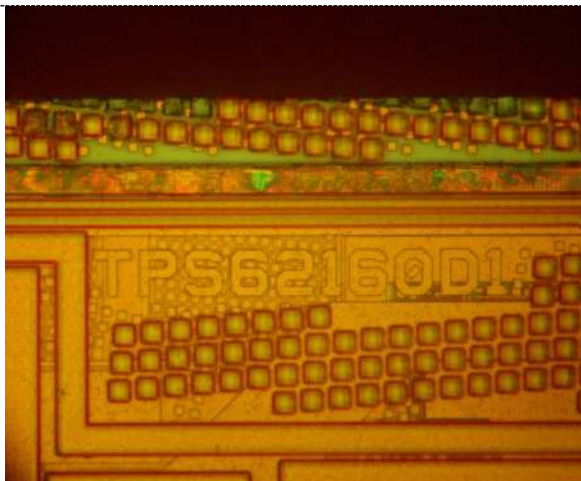
Die Topography

Internal Visual Inspection was verified on 1PCS sample. Manufacturer TI marking was found on the die surface. Die TPS62160D1 was also found on the die surface. Device confirmed to be a TI device.
