Report No:	SZ08262021017
Date:	2021/08/26
Page:	1/23

Project Inspection Report

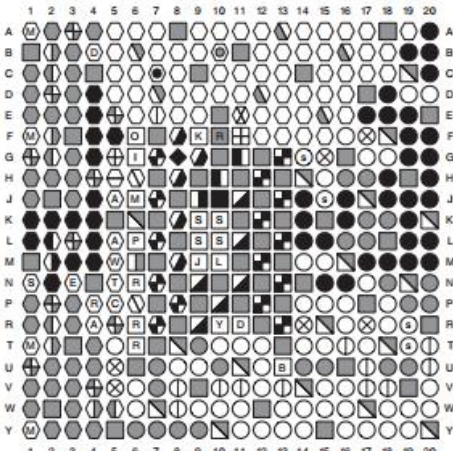
Device Pinout (1)	Device Pinout (2)

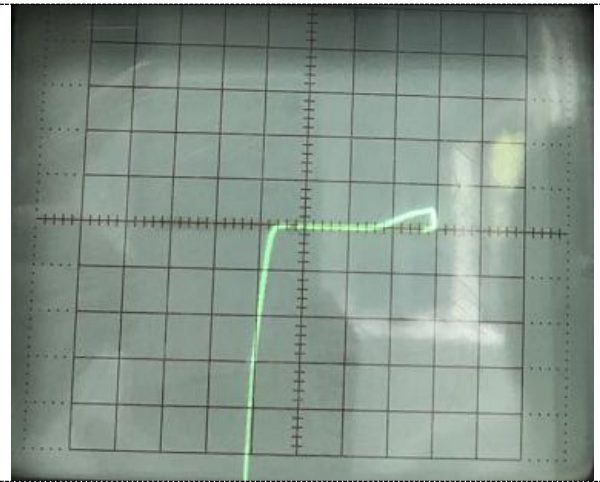
Pin Correlation Test Results:

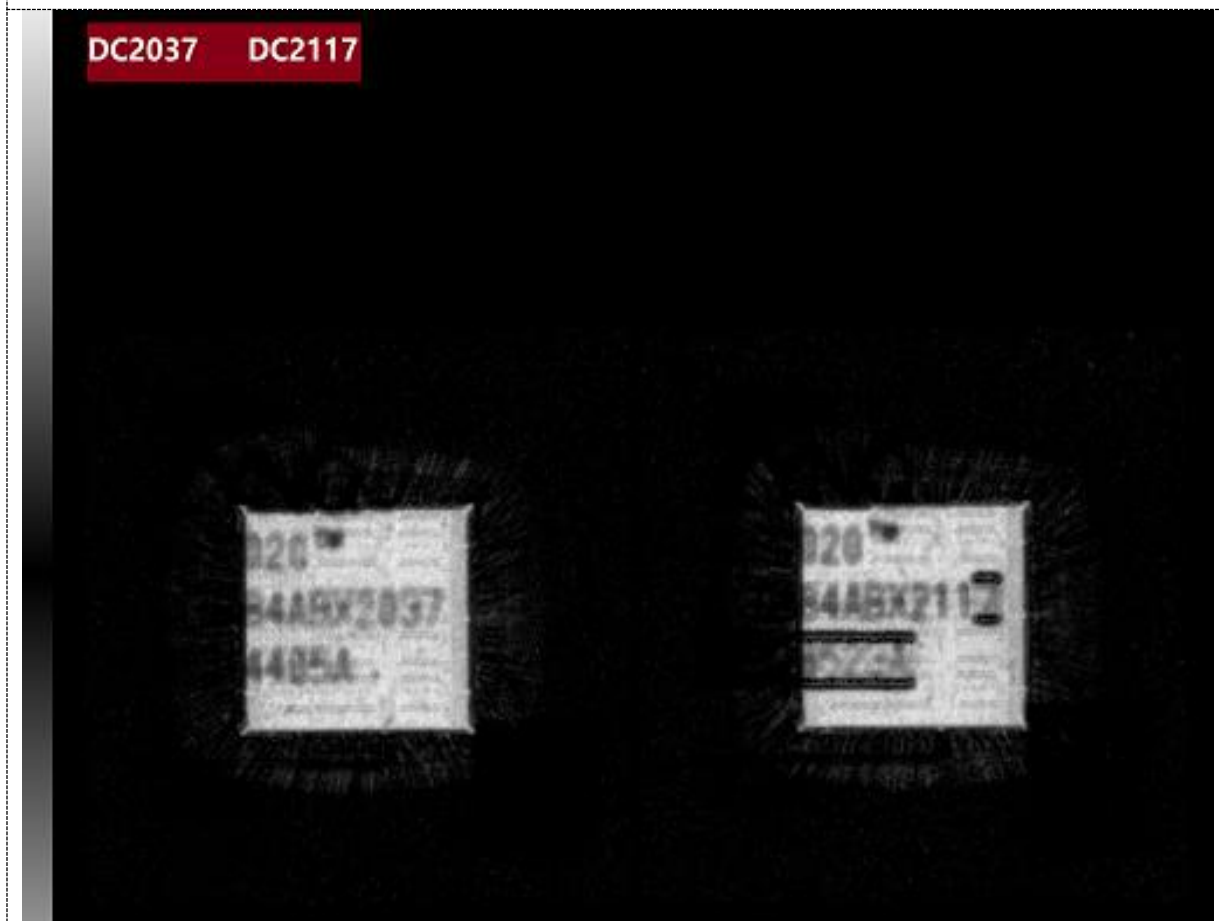
IC(DC2037-DC2117)-50MHz-Die-C
