Intel® E8500 Chipset North Bridge (NB)

Specification Update

June 2005

Document Number: **306747-002**

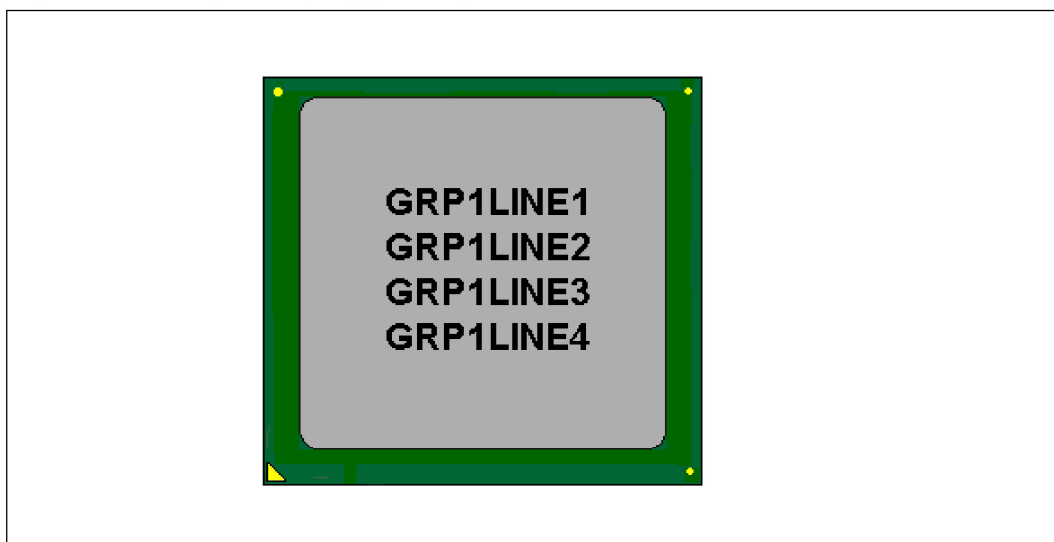
Figure 1. Top-Side Marking Example (optional)

Stepping	QDF-Spec	S-Spec	Top Marking	Notes
B0	QE34ES	N/A	NQ84001TNB	
B0	QG54	N/A	QG84001TNB	Lead free package
